INDOOR AIR QUALITY ASSESSMENT

**Old Rochester Regional High School
135 Marion Road
Mattapoisett, Massachusetts**

Prepared by:
Massachusetts Department of Public Health
Bureau of Environmental Health Assessment
January 2004

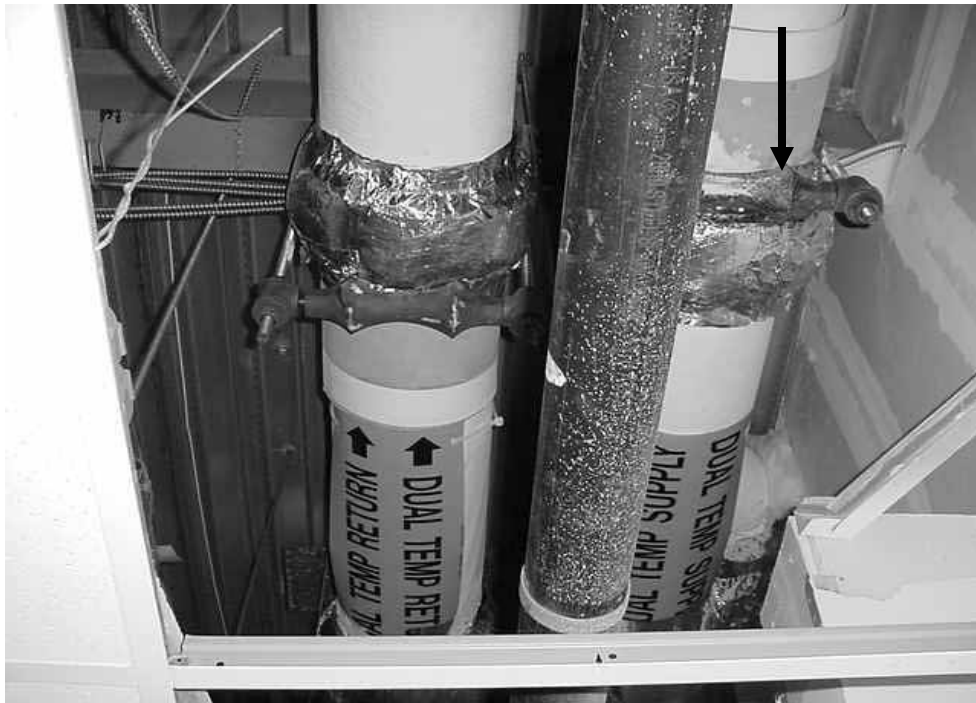
Picture 1

Condensation is the most likely source of moisture that led to mold colonization in pipe insulation (Pictures 1 through 3) and carpeting. BEHA staff noted a musty odor in the band room that was attributed to moistened carpeting. It is possible that these materials were subjected to condensation for an extended period of time. Condensation is the collection of moisture on a surface at or below the dew point. The dew point is the temperature that air must reach for saturation to occur. At a temperature of 83° F and relative humidity of 60 percent, the dew point necessary for water to collect on a surface

Pipe Hanger for Chilled Water Pipe, Note Rust from Exposure to Water

5. Consider consulting a building engineer to determine the extent of the effect of water damage to chilled water pipe and univent insulation. Remediate as needed.

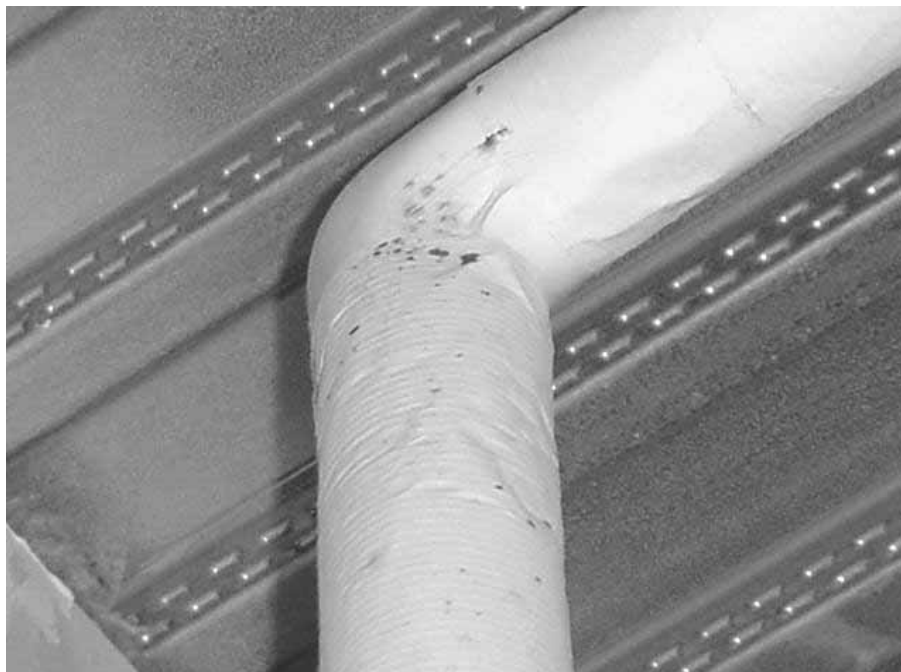
Picture 2

Mold Colonized Pipe Insulation

Location	Temp (°F)	Relative Humidity (%)	Surface Temp gypsum wall board (°F)	Comments
Outdoors	83	60	-	
1720	79	55	-	
Band room	79	66	66	wet carpet, musty odor
Library	75	70	61	
1935	75	67	61	
1021	76	68	63	
0319	73	70	66	Mold colonized pipe insulation in Pictures 2 and 3
0424	74	78	61

1. Continue with plans to remove mold-colonized materials, such as pipe insulation, ceiling tiles, and gypsum wallboard.
2. Remediate mold contaminated building materials in a manner consistent with *Mold Remediation in Schools and Commercial Buildings* published by the US Environmental Protection Agency (US EPA) (US EPA, 2001). Copies of this

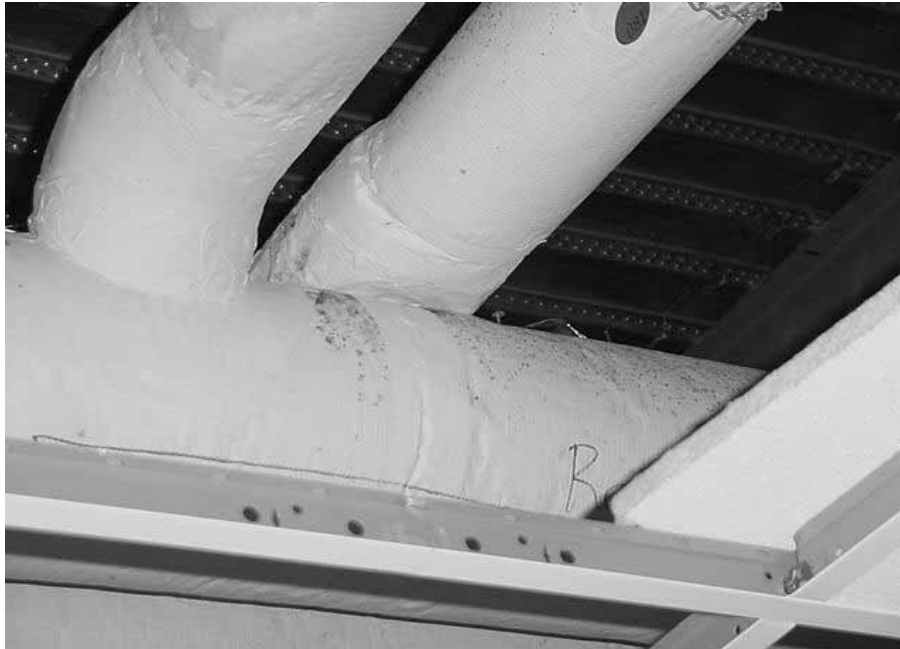
Picture 3

Mold Colonized Pipe Insulation
